# 33 PRESERVATION BRIEFS

## The Preservation and Repair of Historic Stained and Leaded Glass

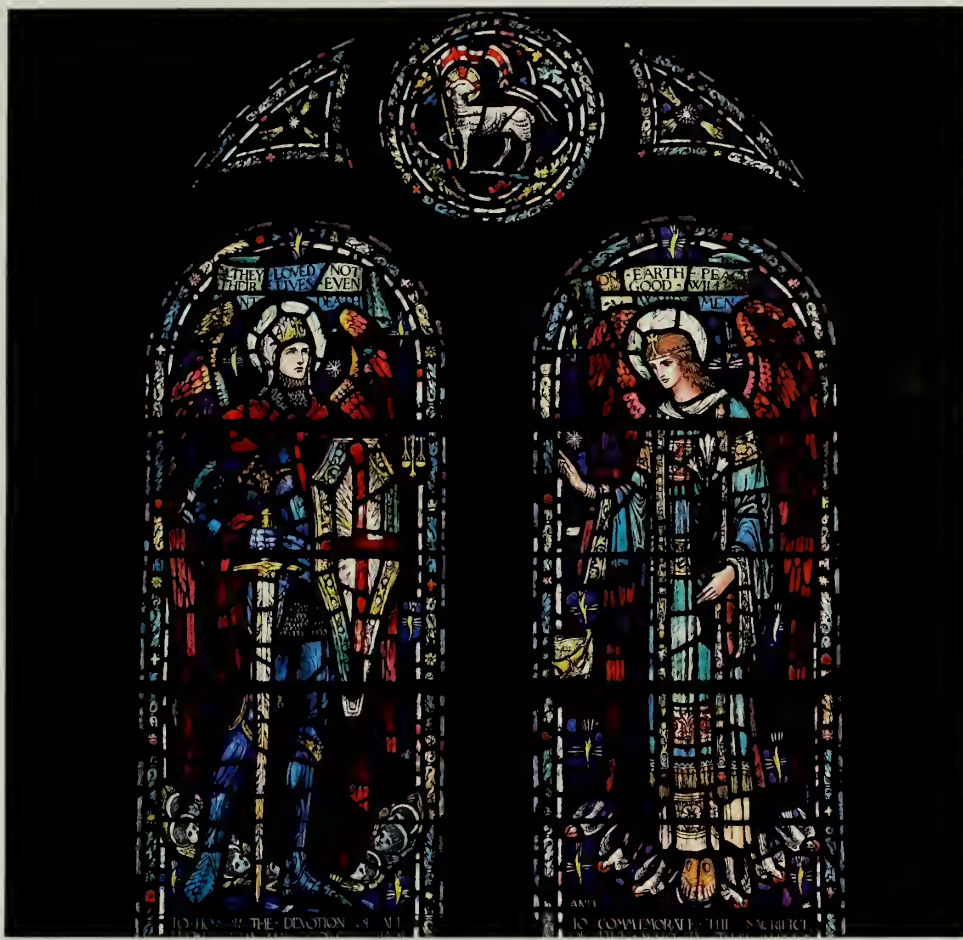
Figure 7. Charles J. Connick was another American master of stained glass. He worked in a modernized Neo-Gothic style. This window is from 1921. Photo: Diana Kincaid.

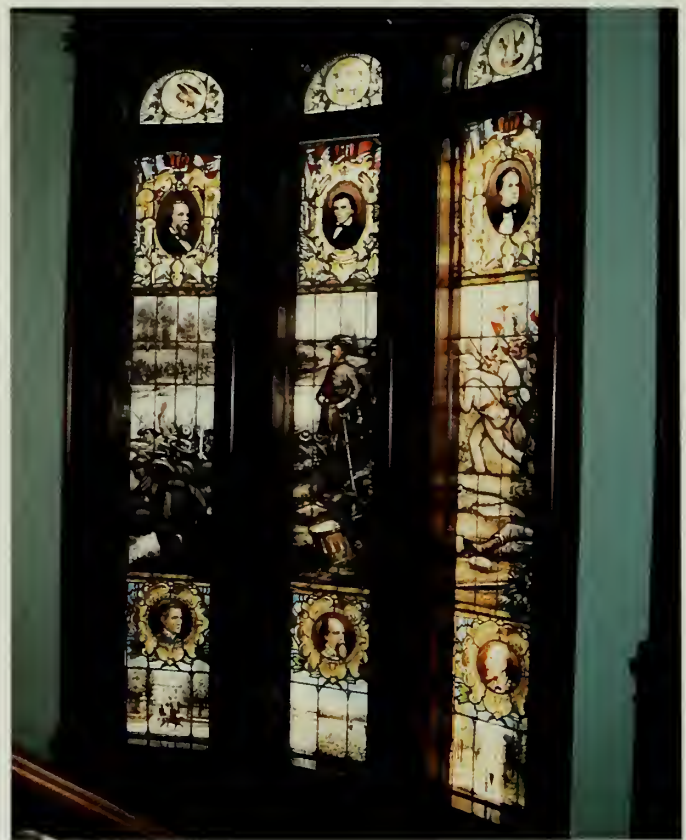
Figure 10. This image illustrates Thomas J. "Stonewall" Jackson and J.E.B. Stuart at the Second Battle of Manassas. The window comprises three of nine panels entitled "The Rise and Fall of the Confederacy" at Rhodes Hall in Atlanta. These windows were executed by Von Gerichten Art Glass Company of Columbus, Ohio, 1905 (installed). A.G. Rhodes reportedly returned one scene to the studio to be redone because the Yankees weren't running fast enough. Photo: Tommy Jones; Courtesy, Georgia Trust for Historic Preservation.

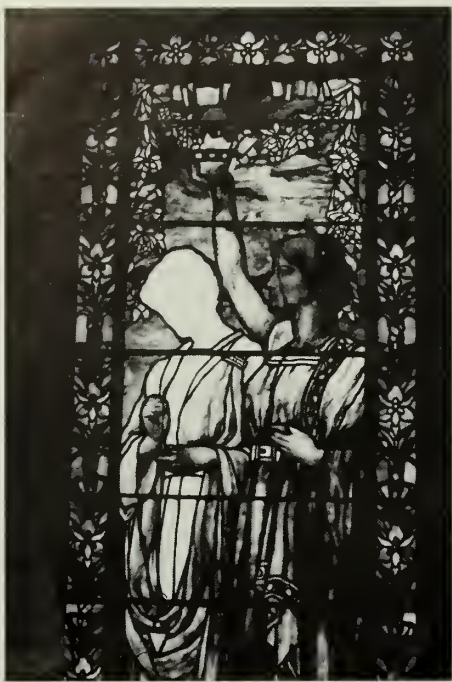
Figure 11. The face paint has failed substantially in the figure at the left. Ghost images of the feature are barely visible. Window (1903) by Edwin P. Sperry, glass by Tiffany Studios; "Old Main," (1891-1893) Illinois Institute of Technology, Chicago. Photo: Rolf Achilles.

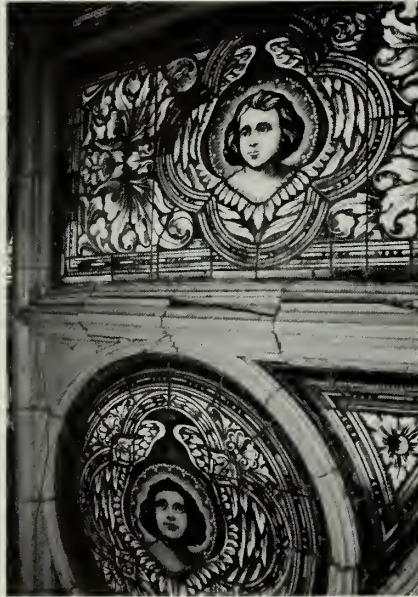
Figure 12. These stained glass angels appear concerned over the cracked terra cotta frames of the rose window they grace. Photo: Neal A. Vogel.

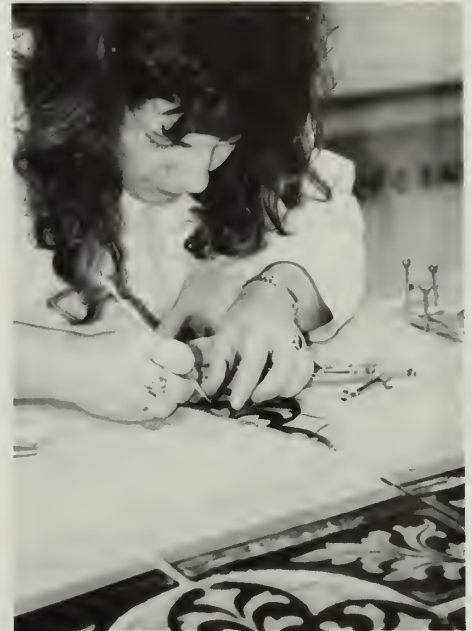
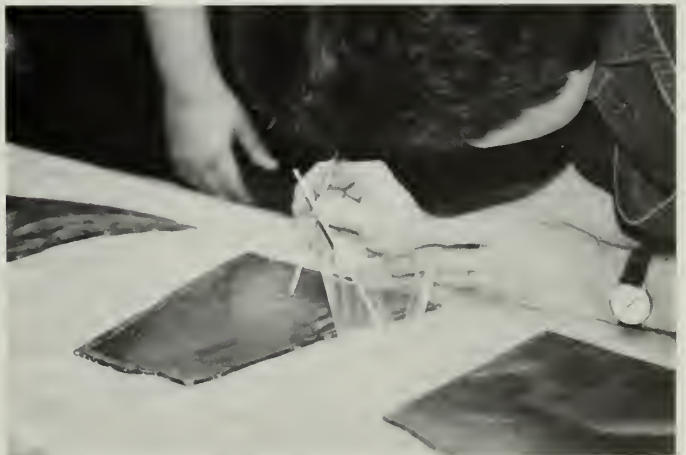
Figure 17. A valuable piece of flashed glass is carefully edge-glued with epoxy and a steady hand. Photo: Neal A. Vogel.
